Super Salvage, Inc.
Industrial Stormwater Inspection Report

Appendix B

Photograph Log and Photographs

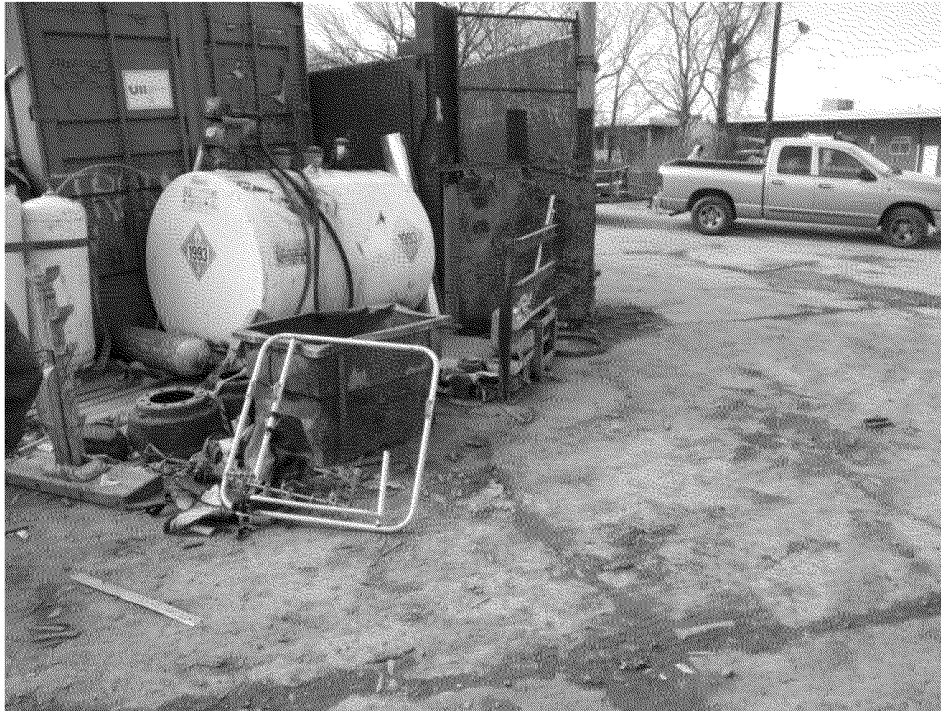
Photograph 53. 500-gallon diesel tank stored by oxygen tanks near Entrance 2.

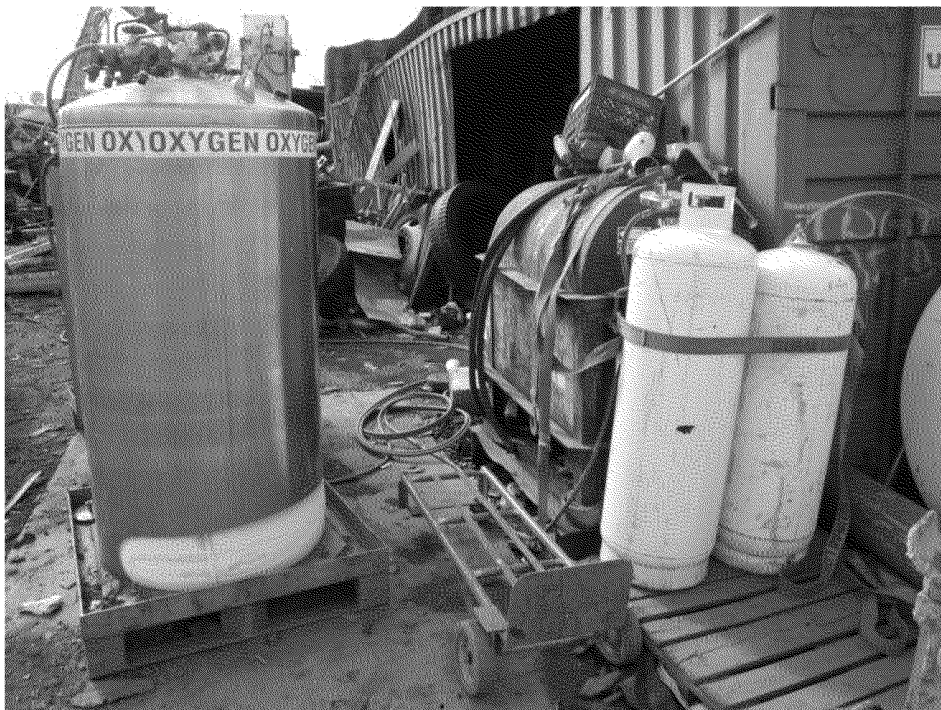
Photograph 54. Compressed gases stored near oxygen tank and fuel used for torches.

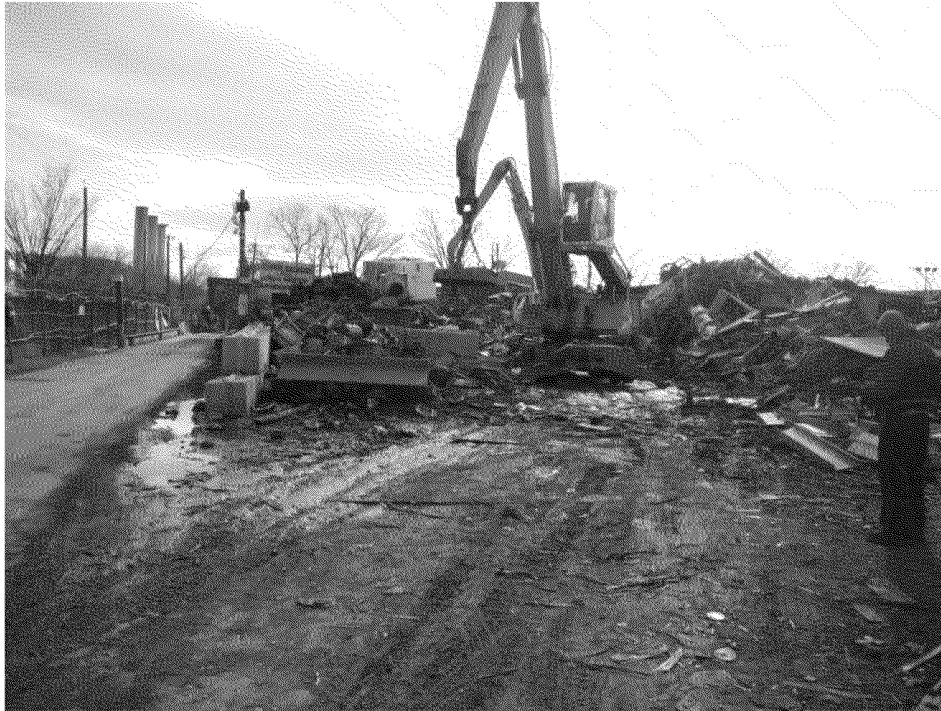
Photograph 55. View of the weigh station and magnet separator near pooling water.

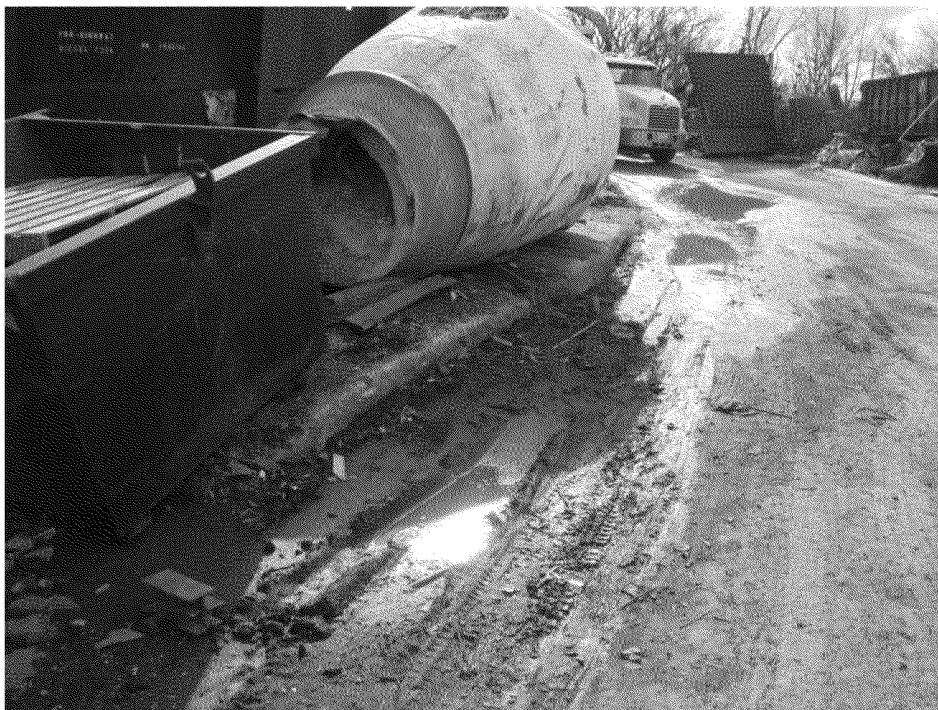
Photograph 58. Storage of debris outside the perimeter of the facility adjacent to the DC property .

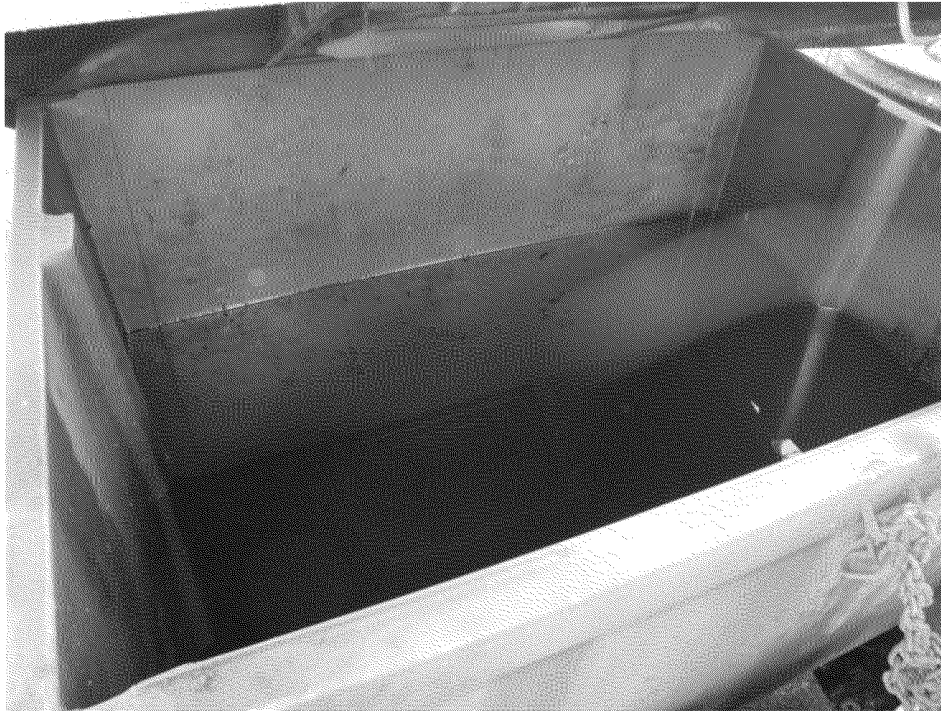
Photograph 71. Plastic container/dumpster of what appears to be waste oil adjacent to the property boundary.

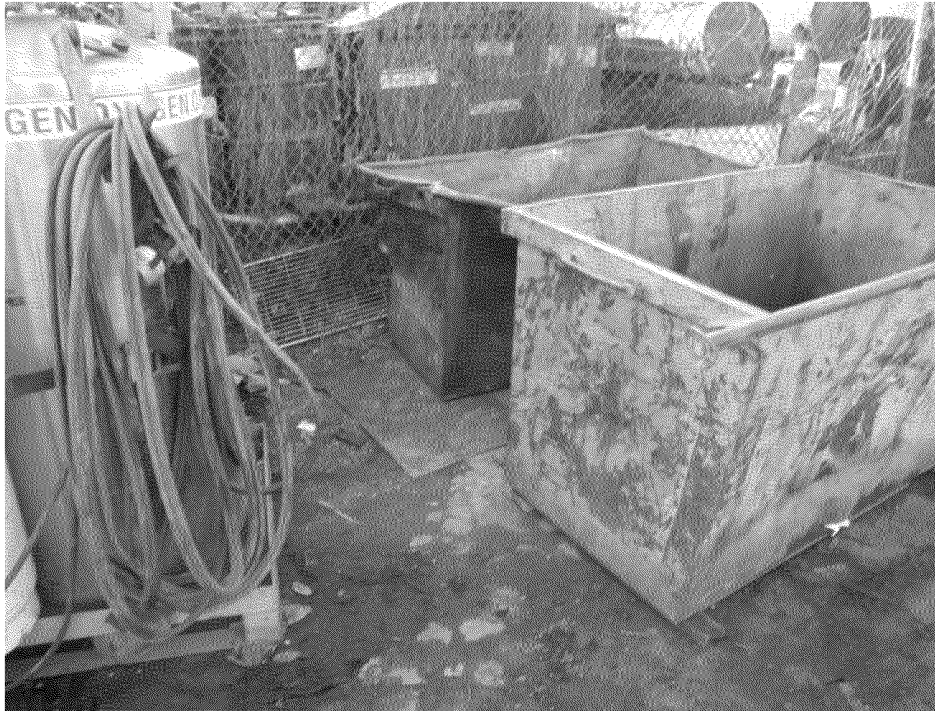
Photograph 77. **Alternate view of items stored outside of the perimeter fence.**

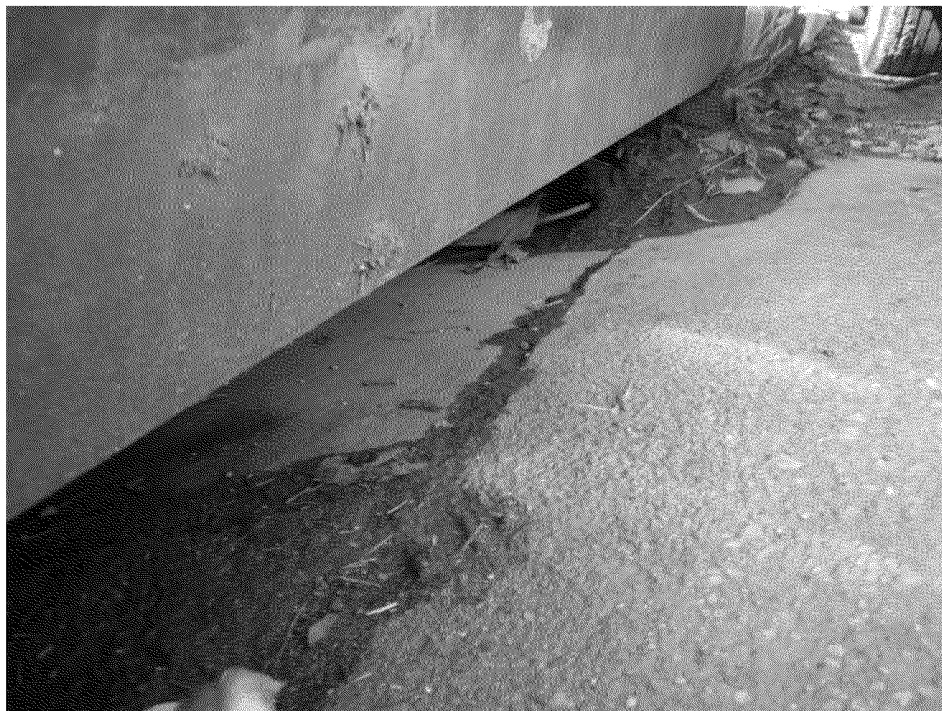
Photograph 81. Close-up view of the storm drain with sediment entering from street.
Storm drain is near the corner of First Street SW and S Street SW.
